Original Article

# 선체 부식 및 손상 부재를 고려한 침몰선박의 구조 안전성 평가에 관한 연구 - 제7 해성호를 중심으로 -

# Structural Safety Assessment of a Sunken Ship Considering Hull Corrosion and Damaged Members - Focus on the Sunken Ship 'No. 7 HaeSung' -

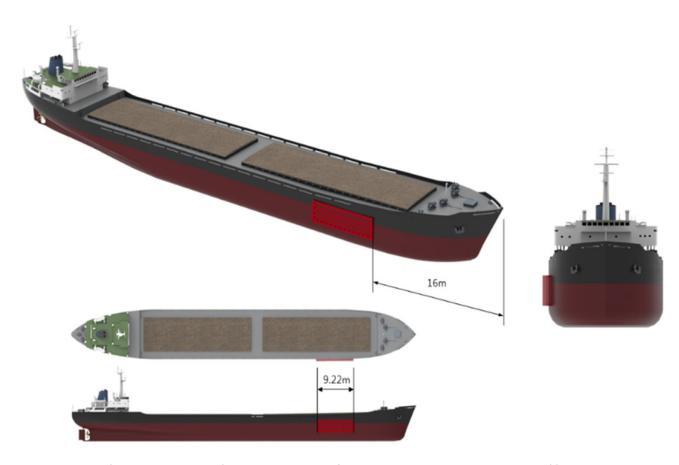
In case of, it can be considered that No.7 HaeSung has sunk because the damage was more than the range values of Table 2. Table 2 shows basic information on sunken ships, and Fig. 2 shows the estimated damage of the hull structure at the time of the accident.

Fig. 2. The Expected Damage of NO.7 HaeSung's Hull Structure.

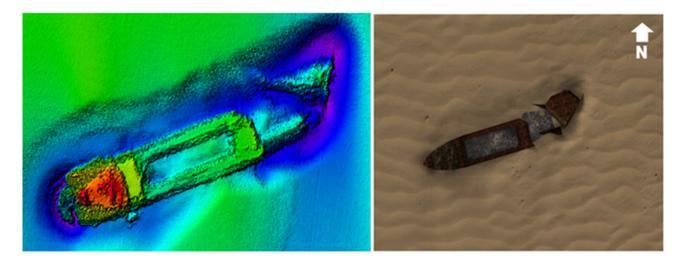
Fig. 3. The Position of the Sunken Ship, 'NO.7 HaeSung'.

As seen in Figure 3, No. 7 HaeSung had the freeboard that was bottomed with the condition toward the northeast and had a collapsed hull. In the vertical position, the freeboard turned upward towards the bow at a degree of  $2\sim6$ , and was about  $0\sim2$  degrees in the horizontal slope. The front body of the cargo hold, No. 1 was inclined to the north at the degree of 20, due to the structural failure.

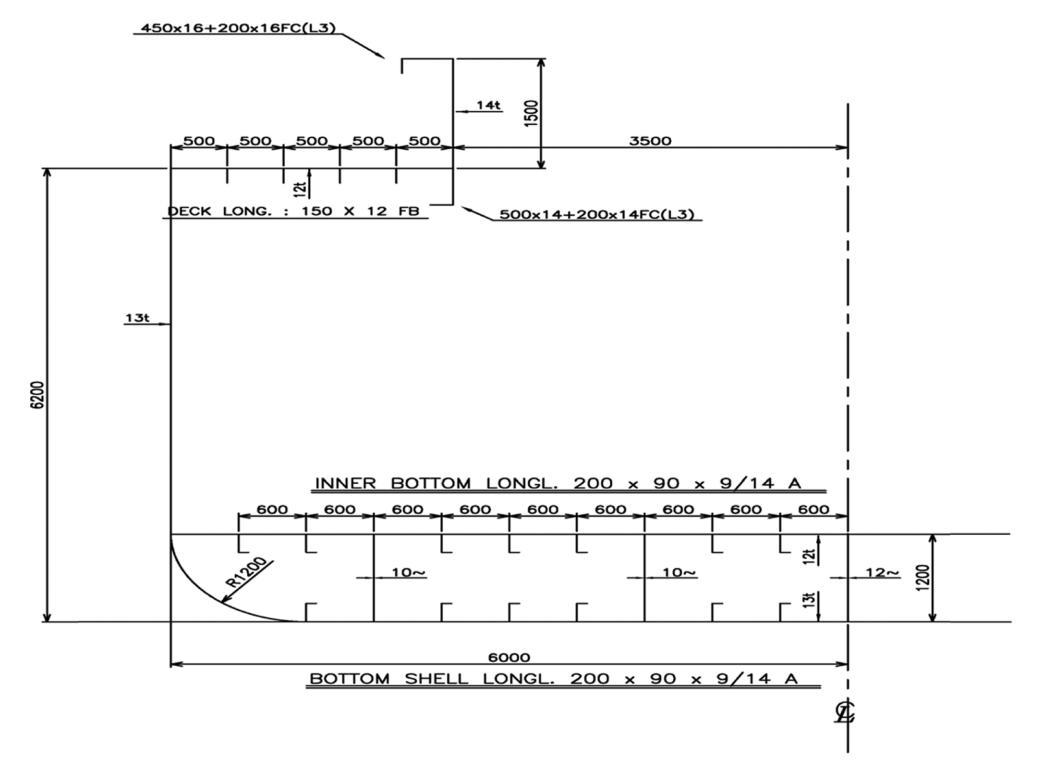
The drawing of the mid-ship cross section shows the size of the hull structure members, the layout of the hull structure, the method for mutual adhering of structure members, etc. The mid-ship section structure occupies more than 60% of the length of the vessel. It further needs to be evaluated after drawing, so that the structural shape of the mid-ship determines the total weight of the vessel and the longitudinal strength. The arrangement of the transverse structure members is determined according to the length and width of the vessel. In this sunken ship, it is determined with reference to the arrangement of the transverse structure members in a similar ship and as per the regulations of the Register. The dimension of the kind girder is referred and chosen by the dimensions of a similar ship. As presented in Figure 4, the general drawing of the mid-ship section of No. 7 HaeSung is shown.

Fig. 4. The Mid-ship Section of 'No.7 HaeSung'.

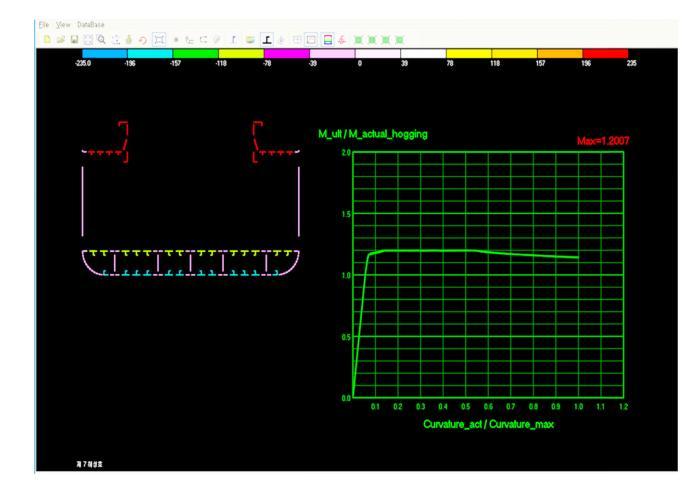
Figure 7 is the screen that revaluates the ultimate strength after applying the degree of corrosion to the hull structure. The value of  $\eta M$  is assumed as 0.63 in the current status, in which there appears to be a low possibility of the failure in the hull

Fig. 7. The Final Strength of NO.7 HaeSung'.

structure. However, there seems to be a high possibility that the hull structure will collapse because of the growth for the degree of corrosion over the time afterward.
